FUEL SYSTEM O-RING LEAKS ON POST P.D.M. C-5A AIRCRAFT

C. J. FORZONO
SA-ALC/MMSH
Kelly AFB TX 78241

SEPTEMBER 1983

FINAL REPORT FOR PERIOD: MAY - SEP 1983

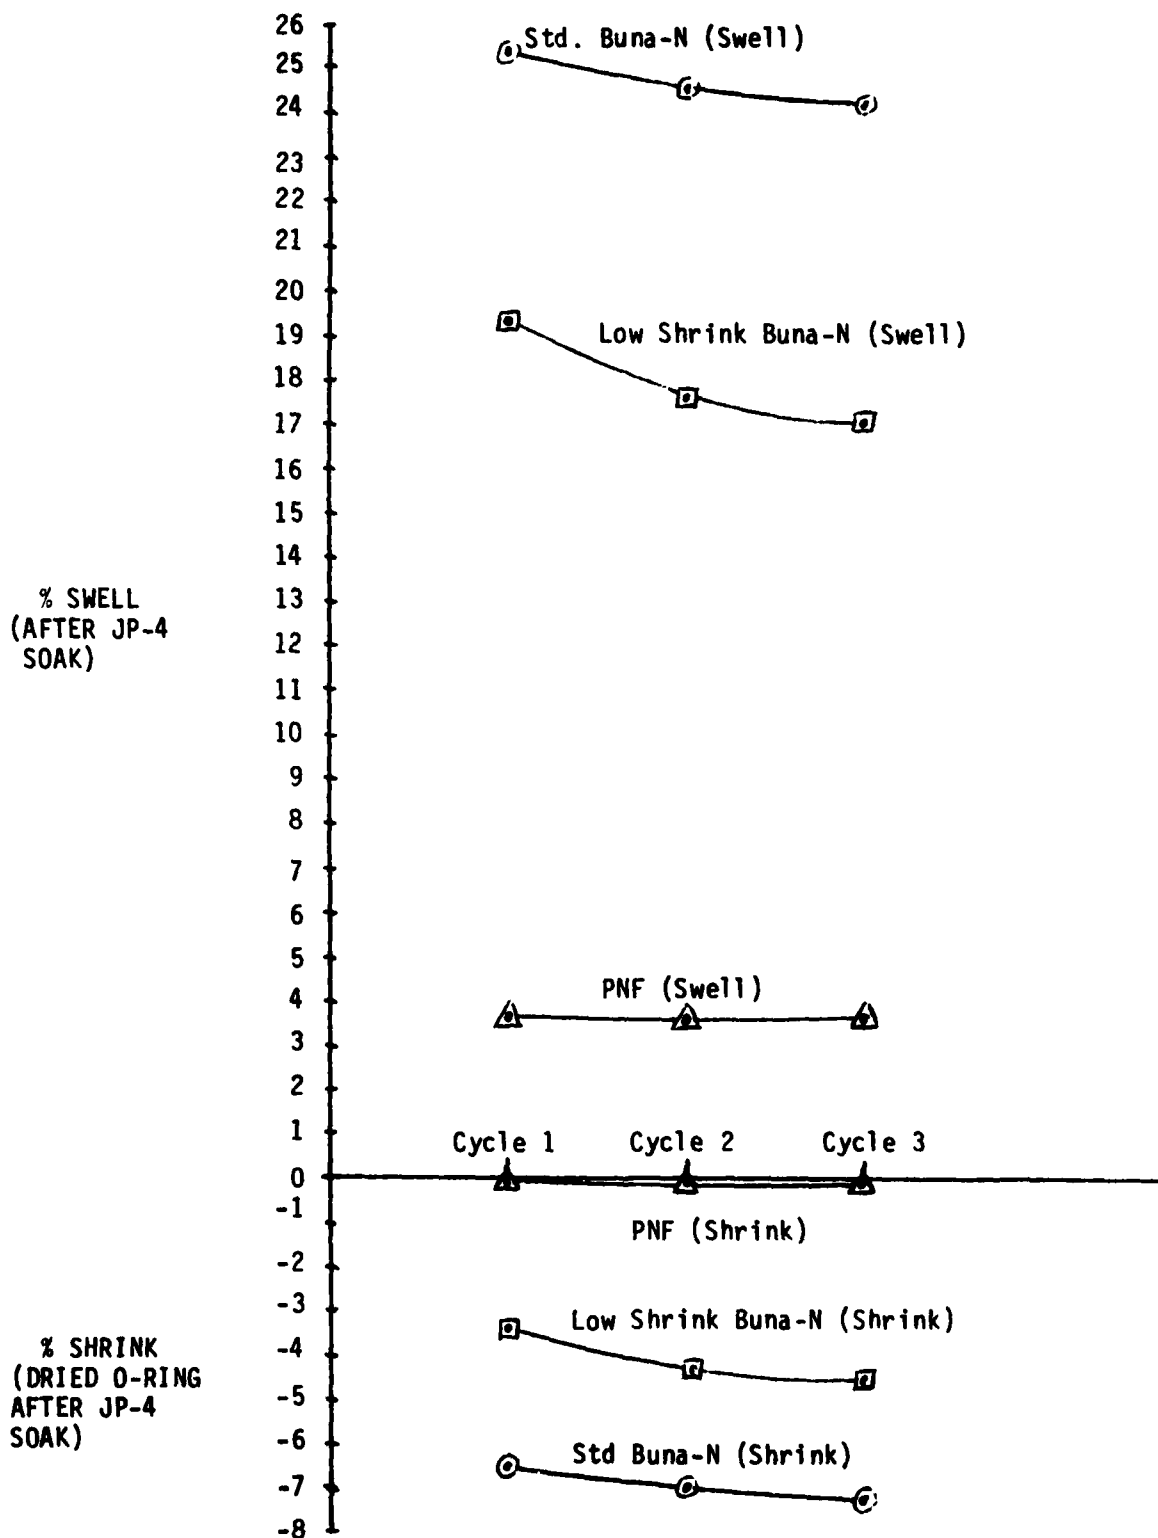
FIGURE 1. SWELL, SHRINK DATA

The standard Buna-N O-ring results show that they swell significantly; as high as 25% above the initial value when immersed in JP-4. Also, with each cycle of immersion and drying, the swelling does reduce; but, only slightly, e. g. from 25.4% down to 24.6% after one cycle. Another significant result for the standard Buna-N is the negative volume changes, or shrinkages, noted after the 48 hour drying periods. The O-rings shrank 6.5% after the first cycle, and got worse with each cycle; e. g. -7% and the -7.2%. These swell and shrink figures match the data found by AFML (see Tables 1 & 2). The tests obviously demonstrate that standard Buna-N O-rings swell in JP-4. This occurs because of the large concentration of aromatic fluids in JP-4 fuel. The shrinking of the standard Buna-N O-rings occurs because the JP-4 reacts with the O-ring and extracts out some of the plasticizers (esters) that contribute to the make-up of the O-ring.^{1, 2}

TABLE 3 Volume Changes of O-Rings (JP-4 Fuel)
